Assessment Report for
Arizona, SPS Experiment 2

Visit date: March 2, 2004

A visit was made to the Arizona SPS-2 site on March 2, 2004 for the purposes of conducting an assessment of the WIM system located on Interstate 10 at milepost 108.55, located between Tonopah, AZ and AZ State Spur 85. The LTPP lane is the driving lane in the eastbound direction.

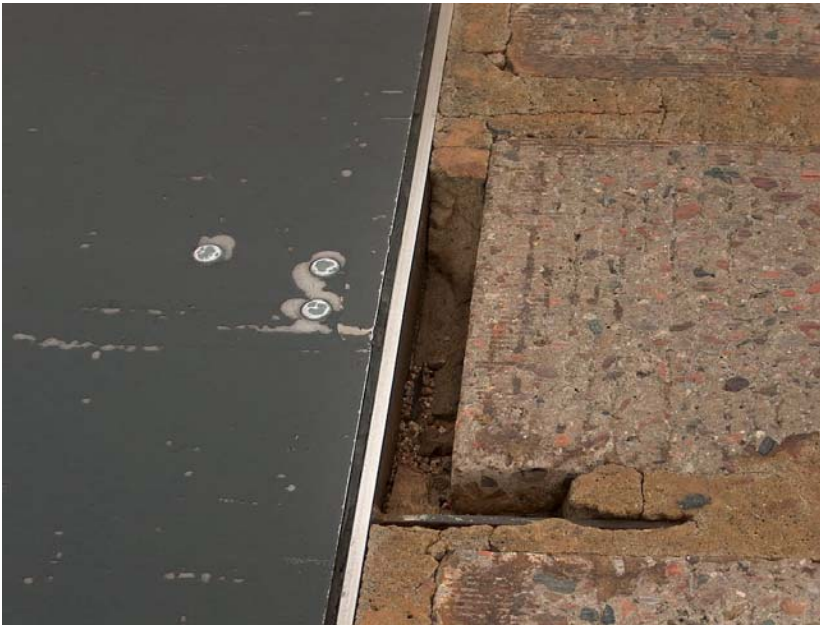
A visual survey of truck movement over the site determined that there is no discernable vertical or horizontal movement of the trucks prior to, passing over, or beyond the WIM scale area. However, there is breakout of epoxy around the right WIM scale, which is directly in the right wheel path. Until this damage is repaired, it may not be possible to calibrate the system to obtain research quality data.

A visual inspection of all on-site equipment such as the cabinet, solar panels, conduit, grounding and inroad sensors was performed. The epoxy on the leading and trailing edges of the right weigh sensor is breaking apart from the scale frame as shown in Figure 13-1. The epoxy is also breaking out of the lead-in conduit channel as shown in Figure 13-2.

Figure 13-1 Epoxy Breakout at Right Load Cell of 040200 (Distress Photo 1)

Repair of the epoxy in the WIM scale area must be performed.

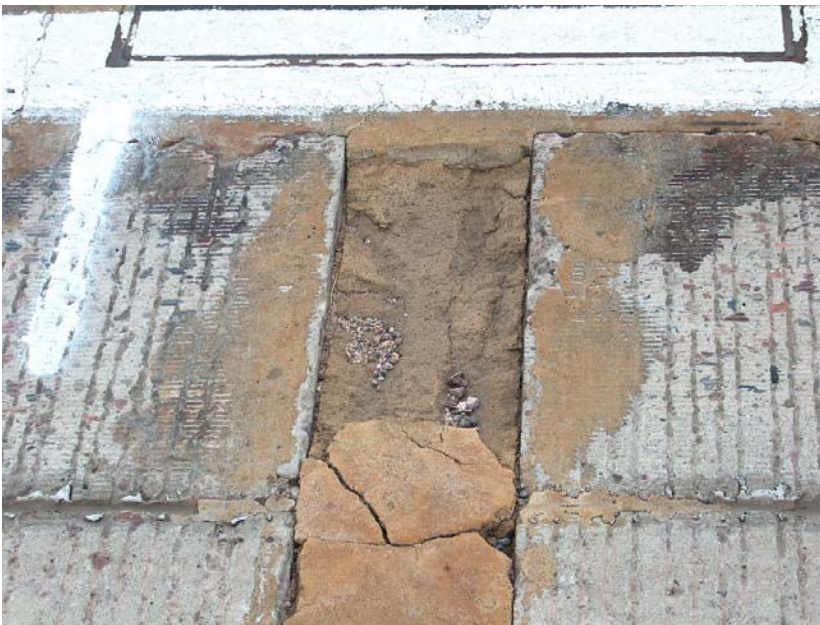
Figure 13-2 Epoxy Breakout at Lead-in Channel of 040200 (Distress Photo 2)

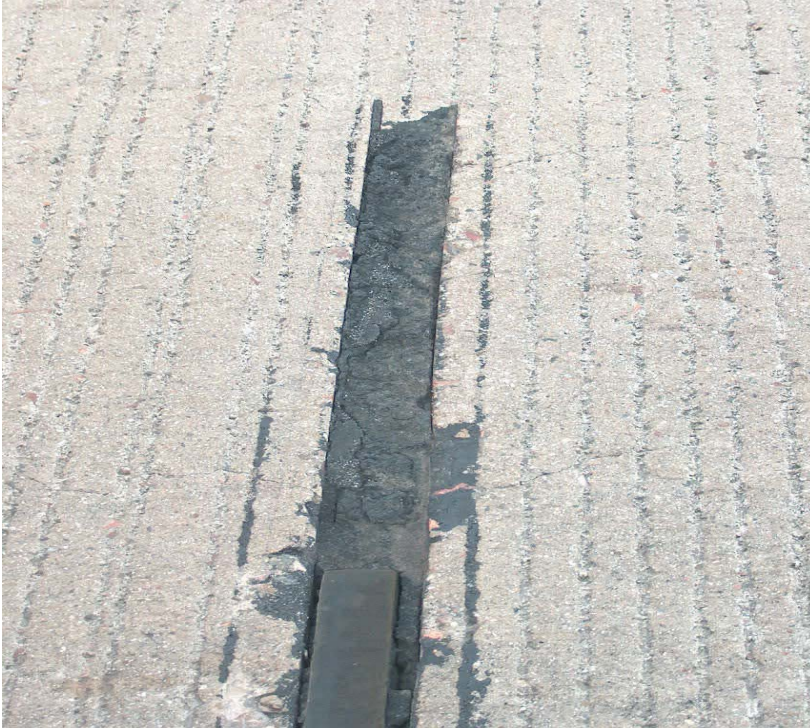
Figure 13-3 Epoxy Breakout at Piezo of 040200 (Distress Photo 3)

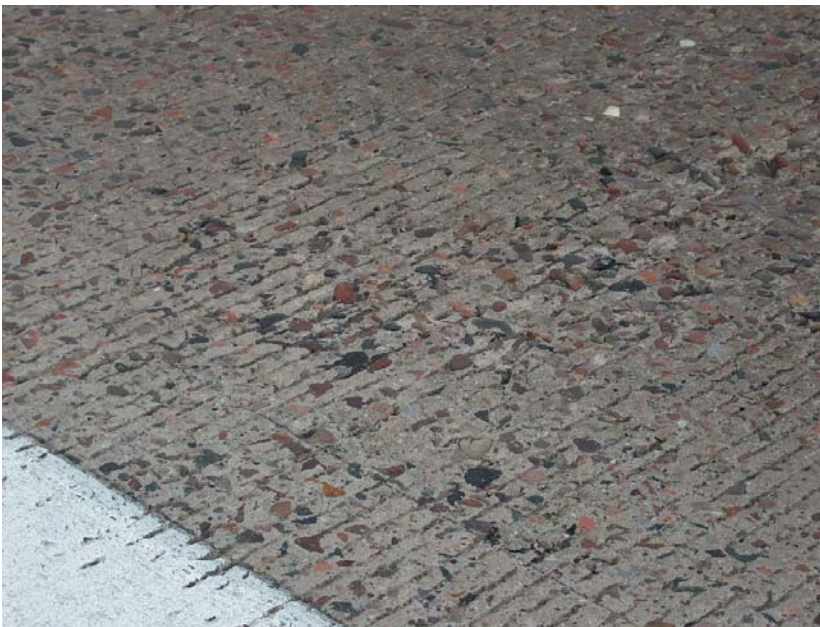
The pavement appears to be in good condition except for the epoxy breakout at the WIM scale. No discernable movement of the trucks, either vertical or horizontal could be detected as they approached, moved over, or exited the WIM scale area. Figure 13-1 through Figure 13-4 show the pavement condition at the site.

Figure 13-4 Polished Aggregate in Pavement of 040200 (Distress Photo 4)

Grinding of the pavement should be performed in order to reduce the roughness.

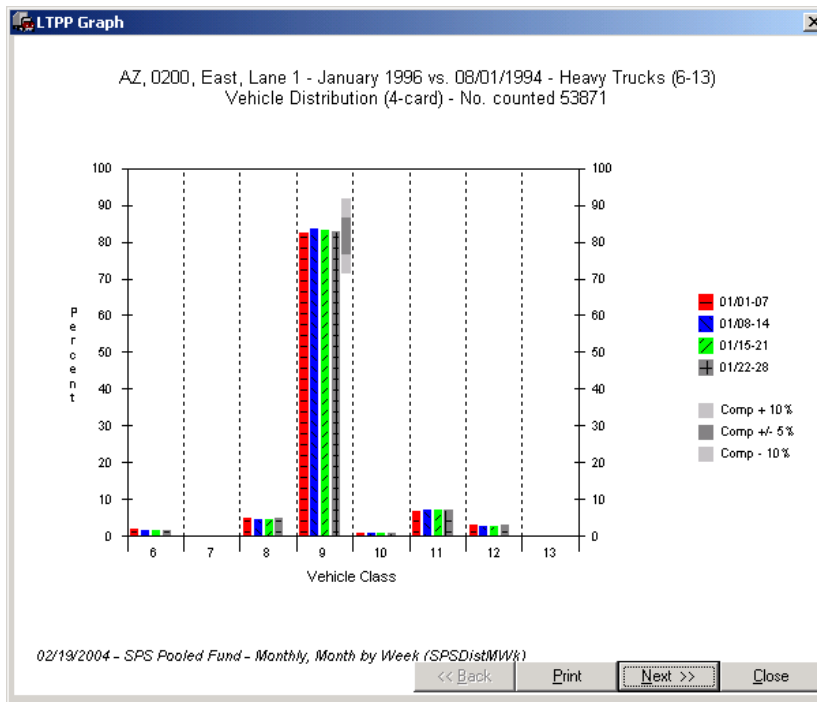
Figure 14-1 shows a typical by week pattern for heavy truck classification data. The individual weeks show essentially the same heavy truck mix. Every vehicle in Classes 6 through 13 that constitutes at least 10 percent of the population is expected to stay within plus or minus 5 percent of the value observed during the two weeks following validation. This range is shown by the darker band inside the lighter band to the right of the weekly

For this site, the fleet mix is essentially similar. A typical graph for this period is shown in Figure 14-1. There was no significant difference in the mix stability graphed for the weight data as shown in Figure 14-2.

Figure 14-1 Typical Heavy Truck Distribution Pattern for Classification Data for 040200

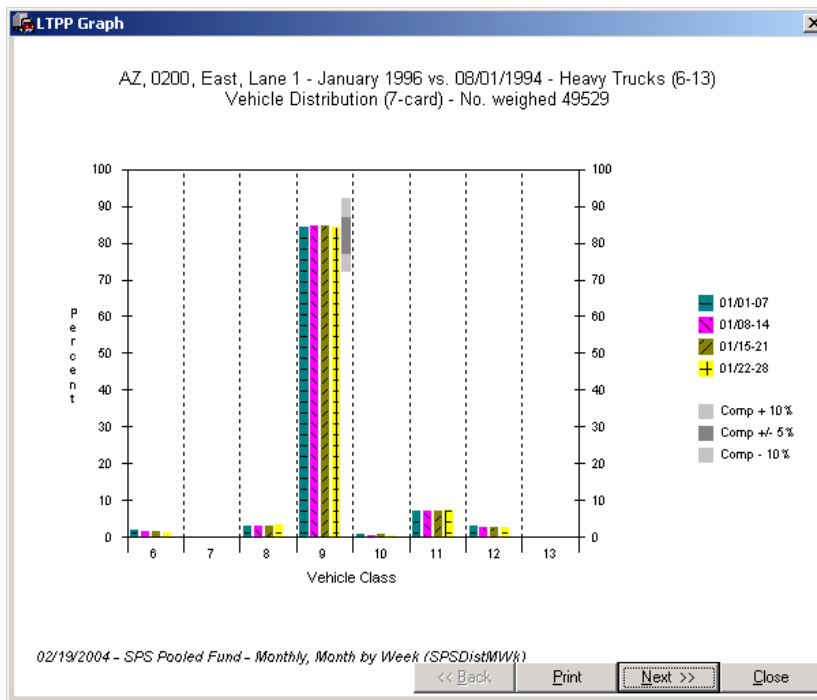
Figure 14-2 Typical Heavy Truck Distribution Pattern for Weight Data for 040200

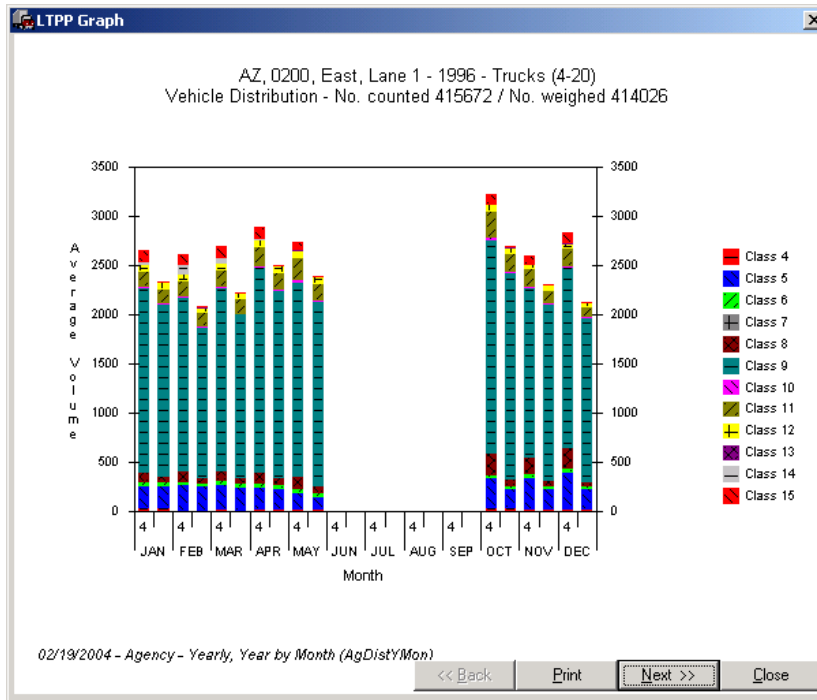
Figure 14-3 shows the typical pattern for vehicle distribution by month by year for the data collected from the classifier versus the data collected by the WIM equipment. From the figure it may appear that the data collected by the WIM equipment has fewer vehicles than the classifier.

Figure 14-3 Vehicle Distribution by Month for the Year 1996 for 040200

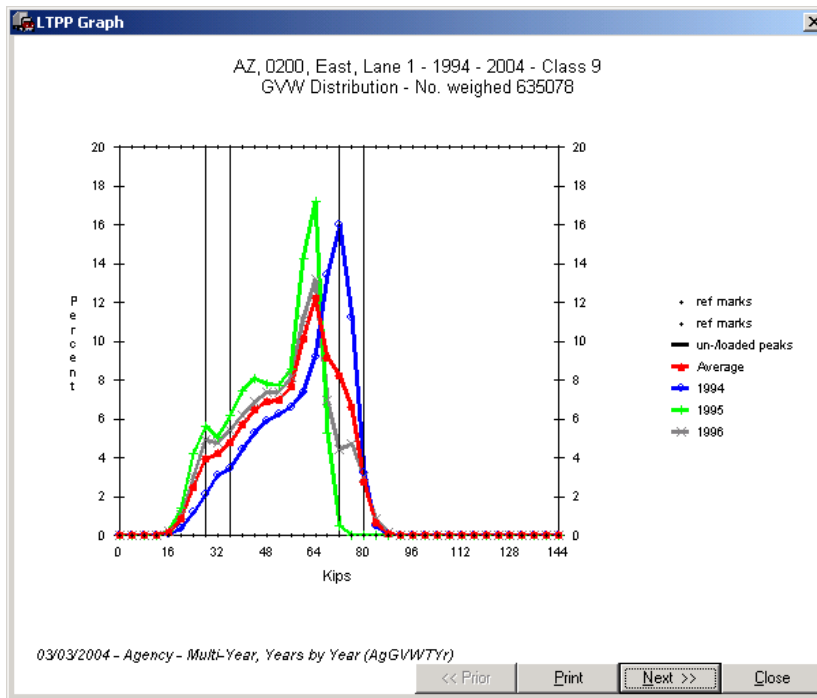
The overall assessment of loading patterns is done using a Class 9 GVW graph by year over the available years. In Figure 14-4 the typical pattern is shown in the gray line with Xs. From the figure it appears that the site is basically a fully loaded site. However, the peak loads for all the years are at the limit of or outside the expected range. Also, the peak loads for all the years were slightly different.

Figure 14-4 Class 9 GVW Distribution – 1994 to 1996 for 040200

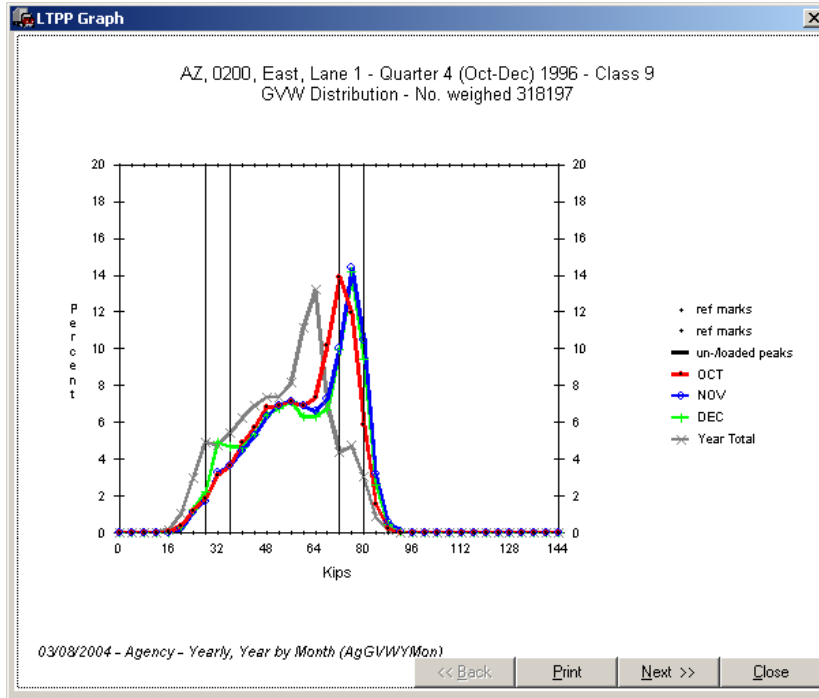
To investigate any seasonal variations the Class 9 GVW distributions are graphed by month by year. As shown in Figure 14-5, based on 1996 data there may be some seasonal variation in weights, given the difference in the fourth quarter curve shapes and locations from the annual average. However, without validation data it cannot be determined if this is reality or an artifact of scale drift.

Figure 14-5 Class 9 GVW Distribution - October 1996 to December 1996 for 040200

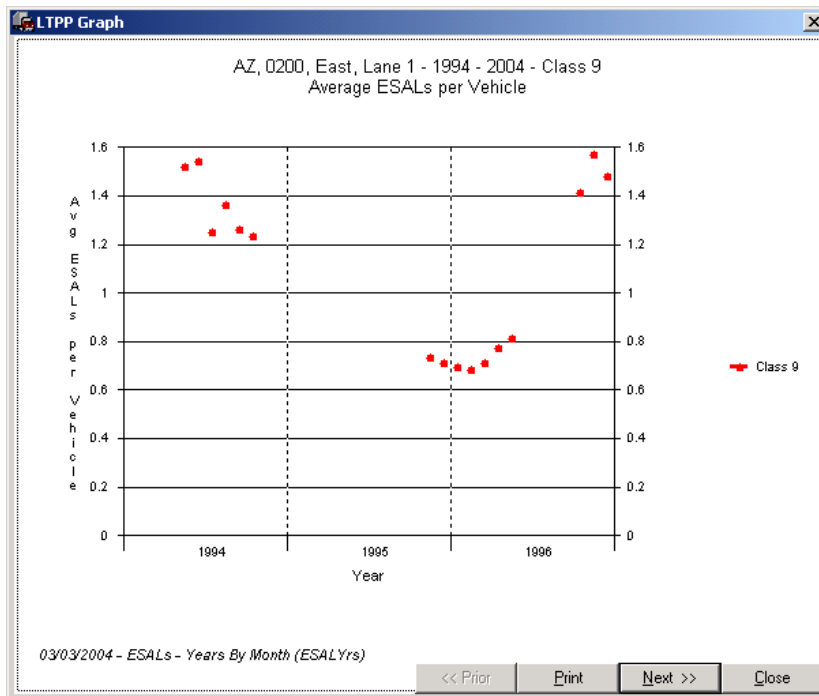
Average ESALs for Class 9 vehicles are a very crude method of identifying loading shifts. Figure 14-6 shows the average Class 9 ESALs per month for this location. To remove the influence of changing pavement structure all ESAL values have been computed with an SN = 5 and a p_t of 2.5. Average ESALs per Class 9 are not used as an indicator of research quality data. . However, the distinct difference between the late 1995 and early 1996 values and the rest of the data re-enforces the need to review the data for reasonability.

Figure 14-6 Average Class 9 ESALs for site from 1994 to 1996 for 040200

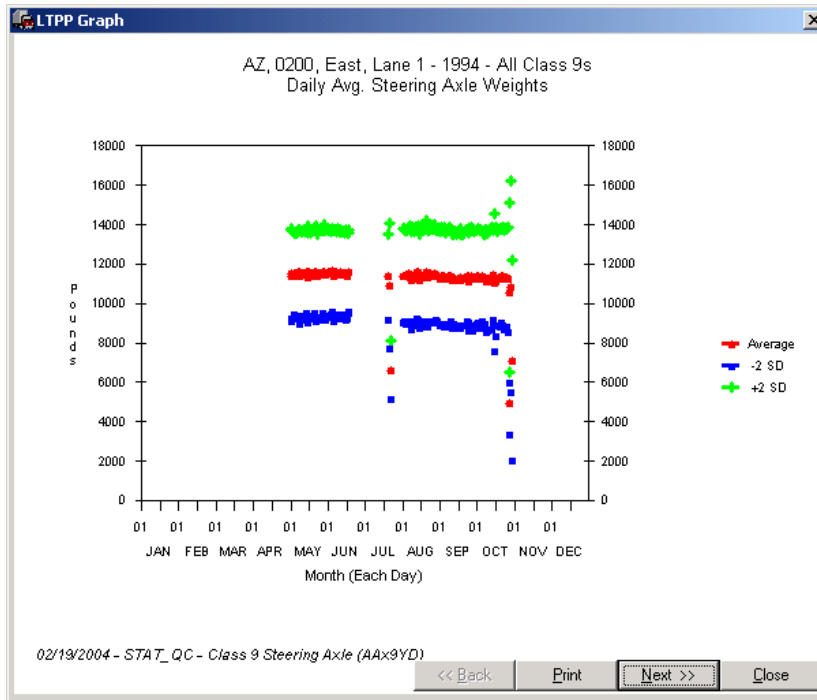
A frequently used statistic for checking scale calibration and doing auto-calibration of WIM equipment is the weight of the front axle. This value is site specific and should be relatively constant particularly for loaded Class 9s (vehicles in excess of 60,000 lbs.). Typically when auto calibration is used this value either cycles repeatedly or with very large truck volumes results in an essentially straight line for the mean. As shown in Figure 14-7 for 1996 the average steering axle weights were essentially the same. There are a few days with suspect data based on the mean steering axle weight being more than two standard deviations below the typical value.

Figure 14-7 Average Daily Class 9 Steering Axle Weight - 1994 for 040200

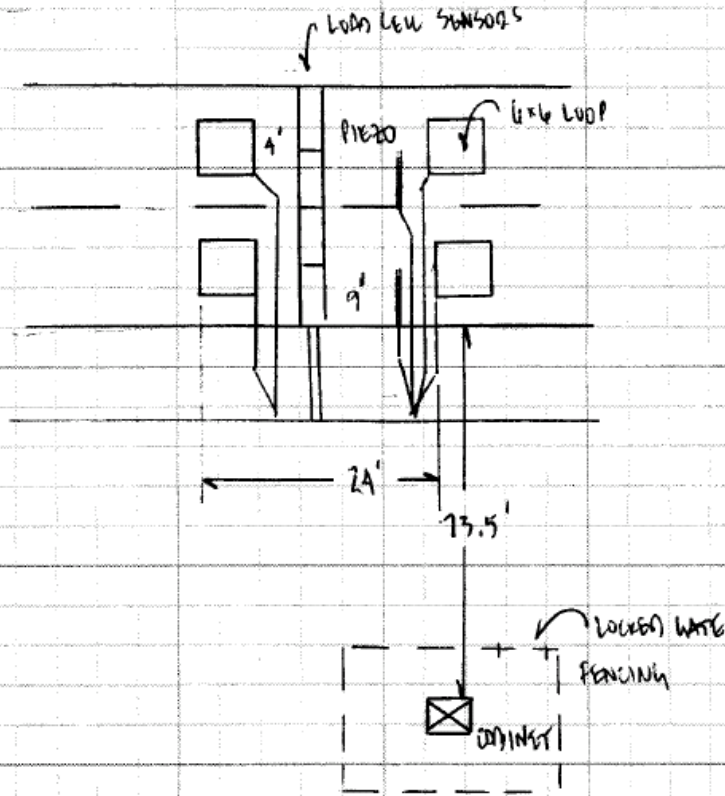
EQUIPMENT LAYOUT

6.* SENSOR SEQUENCE Loop – 2 x Load Cell – Piezo – Loop

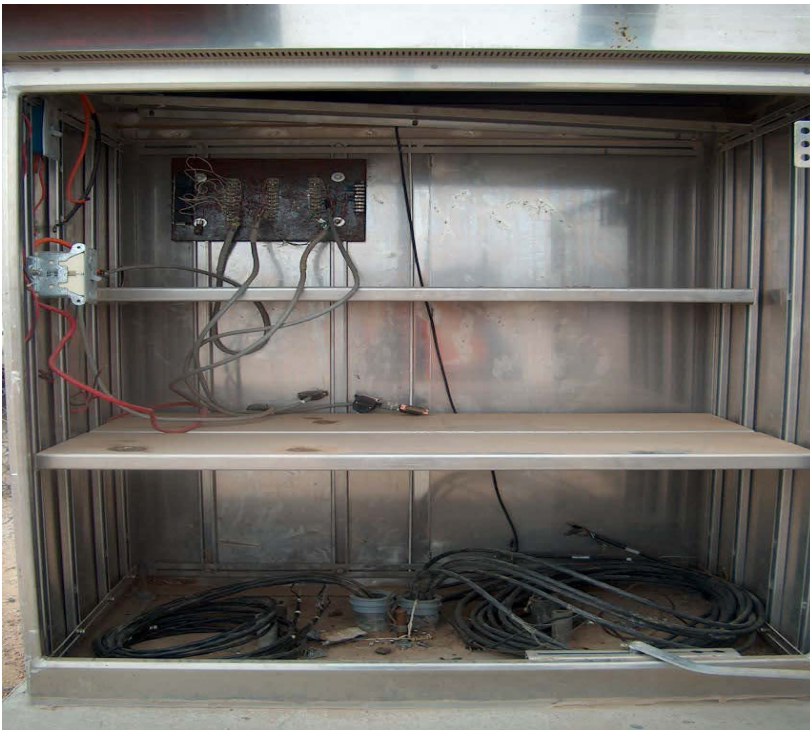
Cabinet_Interior_TO_4_04_25A_0200_03_02_04.JPG

WIM equipment not installed in cabinet, including controller, power panel and communication equipment

The WIM Controller needs to be replaced as well as supporting power and sensor terminal panels. The appropriate number of solar panels with regard to the WIM controller's power consumption needs to be installed in addition to the two panels that are presently installed.

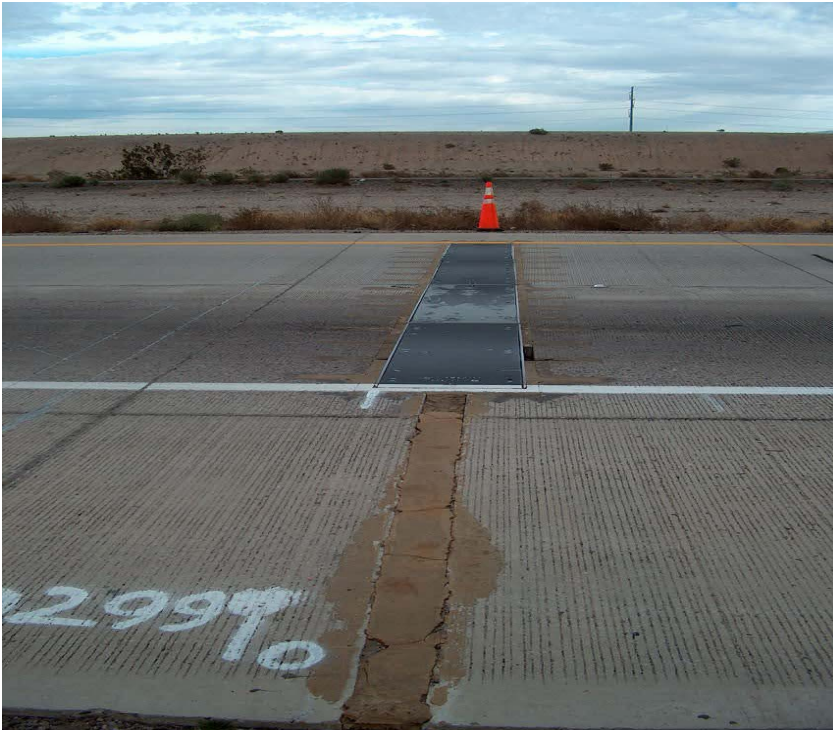
Weight_Sensors_TO_4_04_25A_0200_03_02_04.JPG

Electronic testing of the equipment installed in the pavement indicated that the two weighing sensors need to be repaired or replaced due to high bridge resistance readings. Tests conducted on the loop sensors and the piezo sensor indicated that they were working properly.

Both WIM platforms need to be repaired or replaced due to high excitation resistance and bridge resistance values.
